SERVICE MANUAL

MODEL: RAD226B (RAS376BF)

Mini Hi-Fi System

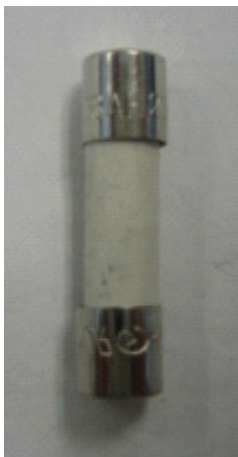
< F901 >
If F901 is not short-circuit,
replace it with a same
specifications one.

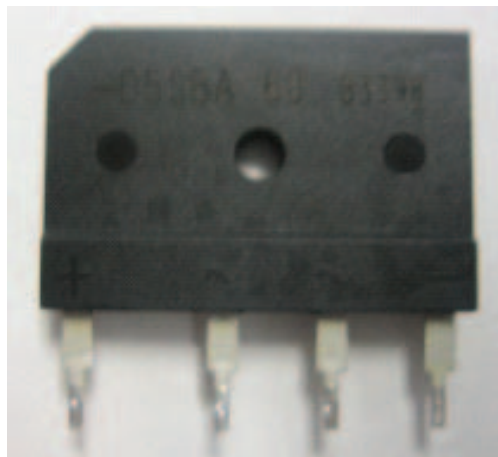
< BD901 >
If BD901 is short-circuit,
replace it with a new one.

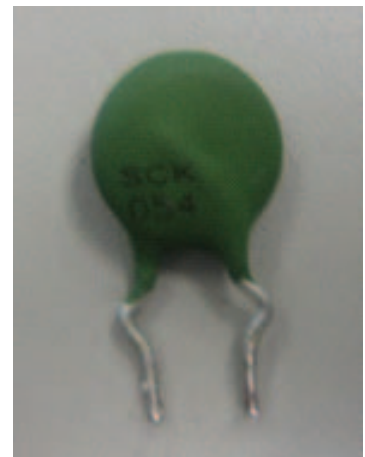
< TH901 >
If TH901 is open,
replace it with a new one.

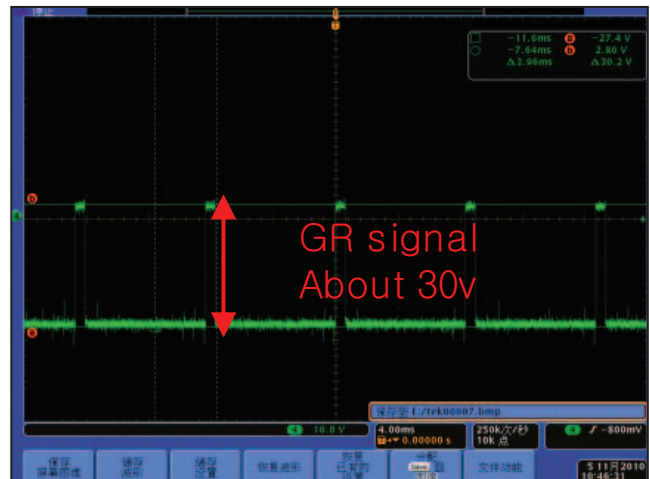
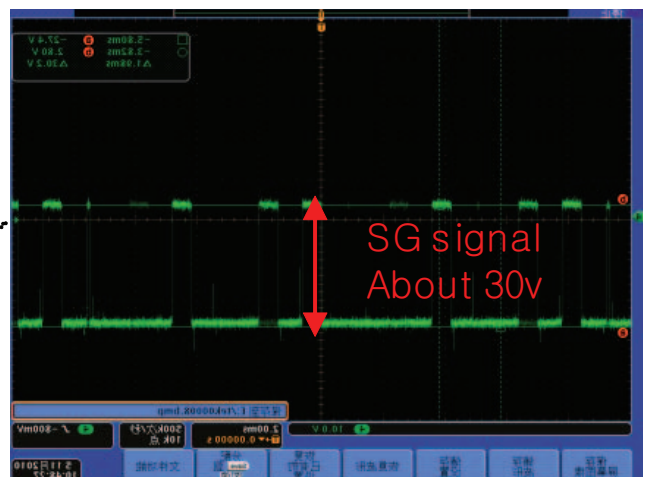
< Waveform of GR and SG signal >

- 1) Check if VKK, FL+ and FL- are output from SMPS to VFD via the MAIN board.
- 2) Check if IC102 outputs VFD_D0, VFD_CLK and VFD_STB to the FRONT board.
- 3) Check the GR signal(pulse signal) of IC501 on the FRONT board.
Check the SG signal(pulse signal) of IC501 on the FRONT board.
 - ⇒ If the GR and SG signal isn't output, replace IC501 with a new one.
 - ⇒ If the GR and SG signal is output, replace DIG502 with a new one.

Click the picture, and then drag to enlarge it.
check the waveform on details.
