## TX809 Audio Processing Block Diagram

### Audio Processing

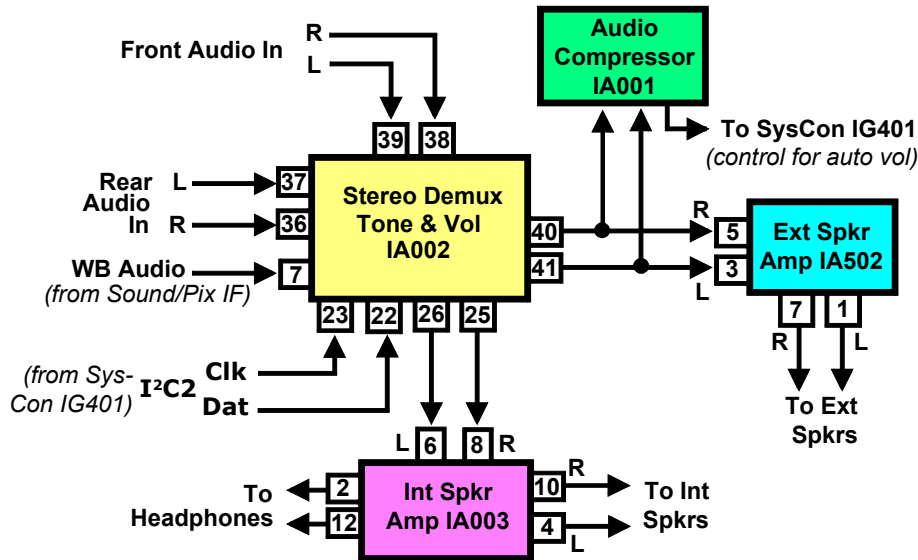
The TX809 audio circuit is comprised of a Stereo De-Multiplexor (IA002) and two (2) amplifier IC's, IA003 and IA502. IA002 is responsible for decoding the stereo signal into left and right channels and also provides for tone and volume control. Amplifier IA003 drives the internal speakers while IA502 provides drive for the external speakers. IA003 also has an output for the headphones. The stereo de-multiplexor is controlled by the System Control uC, IG401 via the I<sup>2</sup>C2 bus. The wide band (WB) audio from the Sound/Pix IF is input to IA002 pin 7. The front and rear audio inputs are applied directly to IA002 pins 36 through 39. All switching and signal selection are accomplished in IA002 via control from the I<sup>2</sup>C2 bus. The sound compressor (IA001) serves to compress the audio dynamic range by minimizing any sudden and undesirable changes in audio level. The output from the Sound Compressor is a DC control signal that is applied back to the system control IC, IG401. IG401 then communicates the desired changes back to IA002 via the I<sup>2</sup>C2 bus.

1. Check for audio power supplies to audio circuits.
2. Confirm speakers are not shorted or open.
3. If problem appears to be stereo related, inject stereo signal (from generator) into pin 7 of IA002 and check signal path.
4. If problem is external input related, inject know mono audio signal and check signal path.
